## 'HOLES?! I DON'T SEE THOSE ON THE UTILITY SHEETS!'

Dar Hao Chen, Ph.D. PE.

Jason Duncan, PE Juan Gonzalez

Section Facts	
FM 1858/Tokio Road to FM 1242	
<b>Construction Start:</b>	September 2011
Anticipated Completion:	Spring 2015
Length:	8 miles
Cost:	\$101 million
Contractor:	Webber Construction

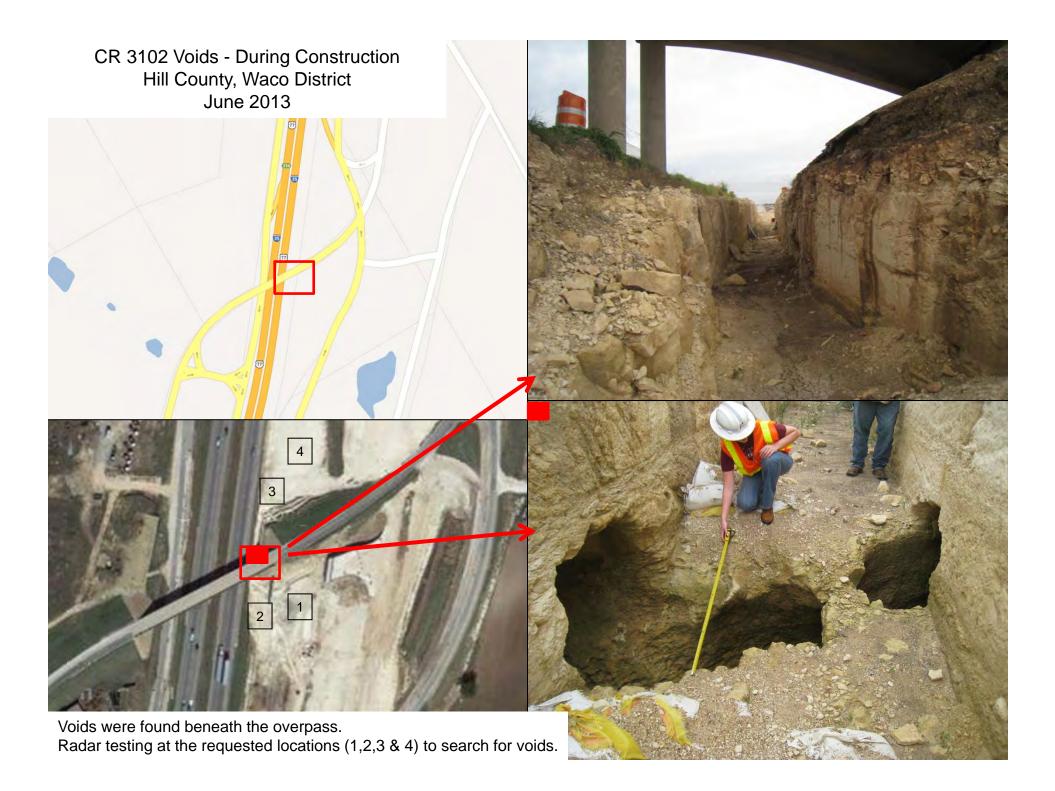
Area scanned by the Ground Coupled Radar. South of the overpass.

#1 – Anomalies found did not have strong signals typical of large voids.

#2 - Birds Eye picture is not current.Material along side IH-35N has been removed.Informed by contractor that voids were discovered.

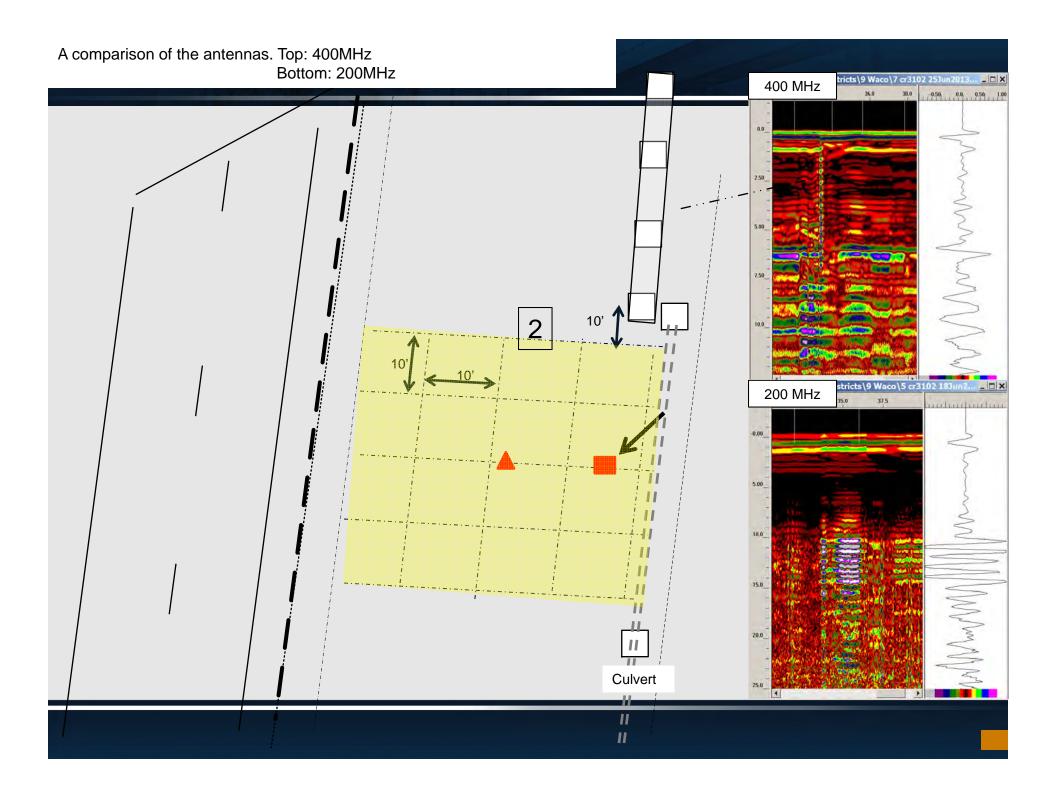
#### CR 3102

200 MHz Antenna North of overpass. Signal test was done over the culvert. Anomaly displaying a negative signal is measured at 3 feet. The culvert is dry.

200 MHz Antenna South of overpass. Signal test was done over the culvert. Anomaly with negative signal is visible at 3 ft. Water is visible in the culvert. Moisture in the area may have caused the extra signals.

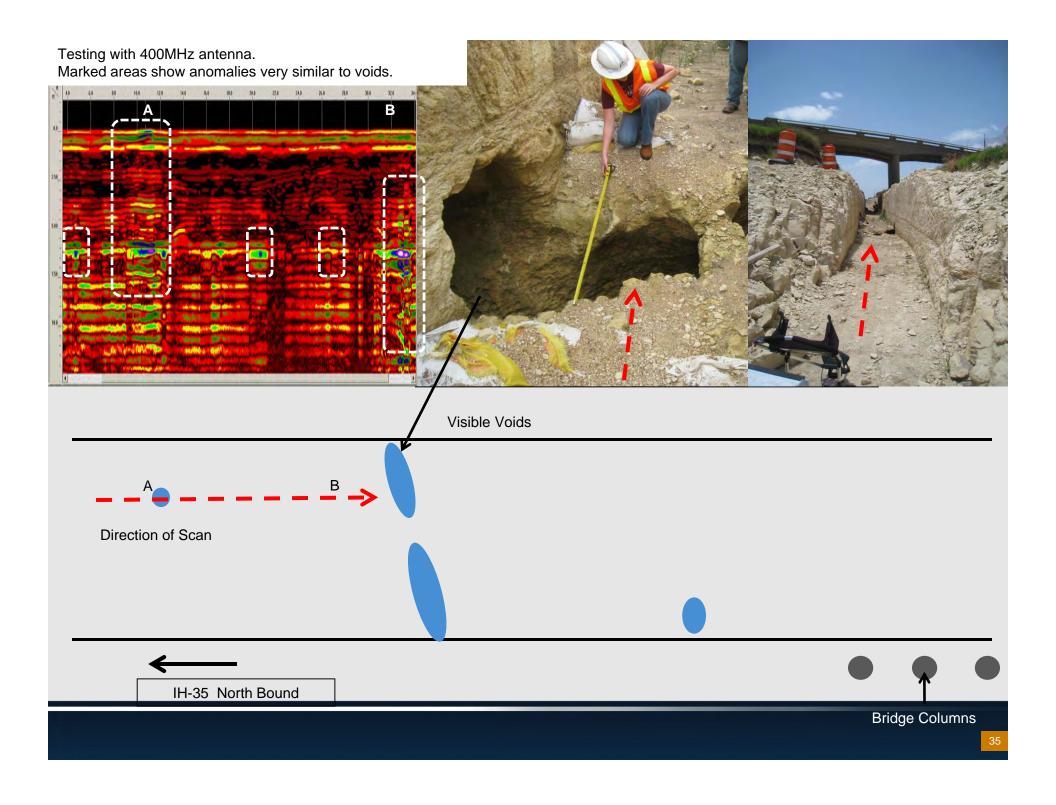
Similar examples using the 400 MHz antenna. These examples were at depths of approximately 6 & 9 ft.

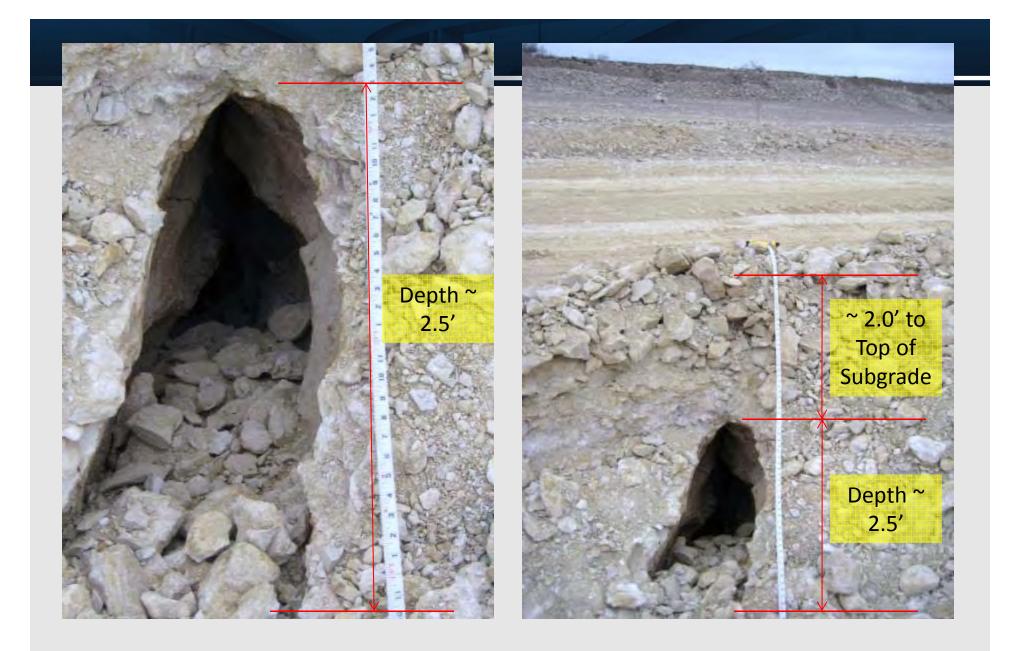
US 281,Comal Co., San Antonio Dist. 400 MHz Antenna Anomaly signal found at 28 inches.

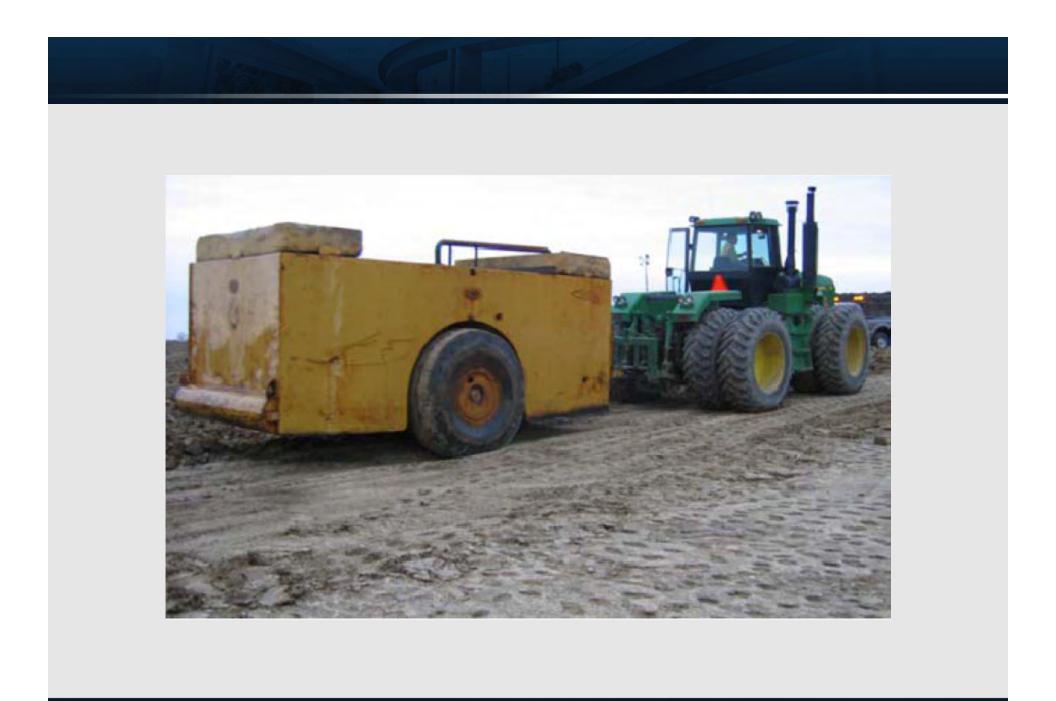
Figure 1.2. Schematic of deformation resulting from test roller wheel penetration
