**BEFORE-AND-AFTER STUDY OF THE EFFECTIVENESS OF
RECTANGULAR RAPID-FLASHING BEACONS USED WITH
SCHOOL SIGN IN GARLAND, TEXAS**

2012 TexITE Technical Paper Award
Words: 3056 + 3*250 (tables) + 4*250 (figures) = 4806 words
Submitted: April 2012

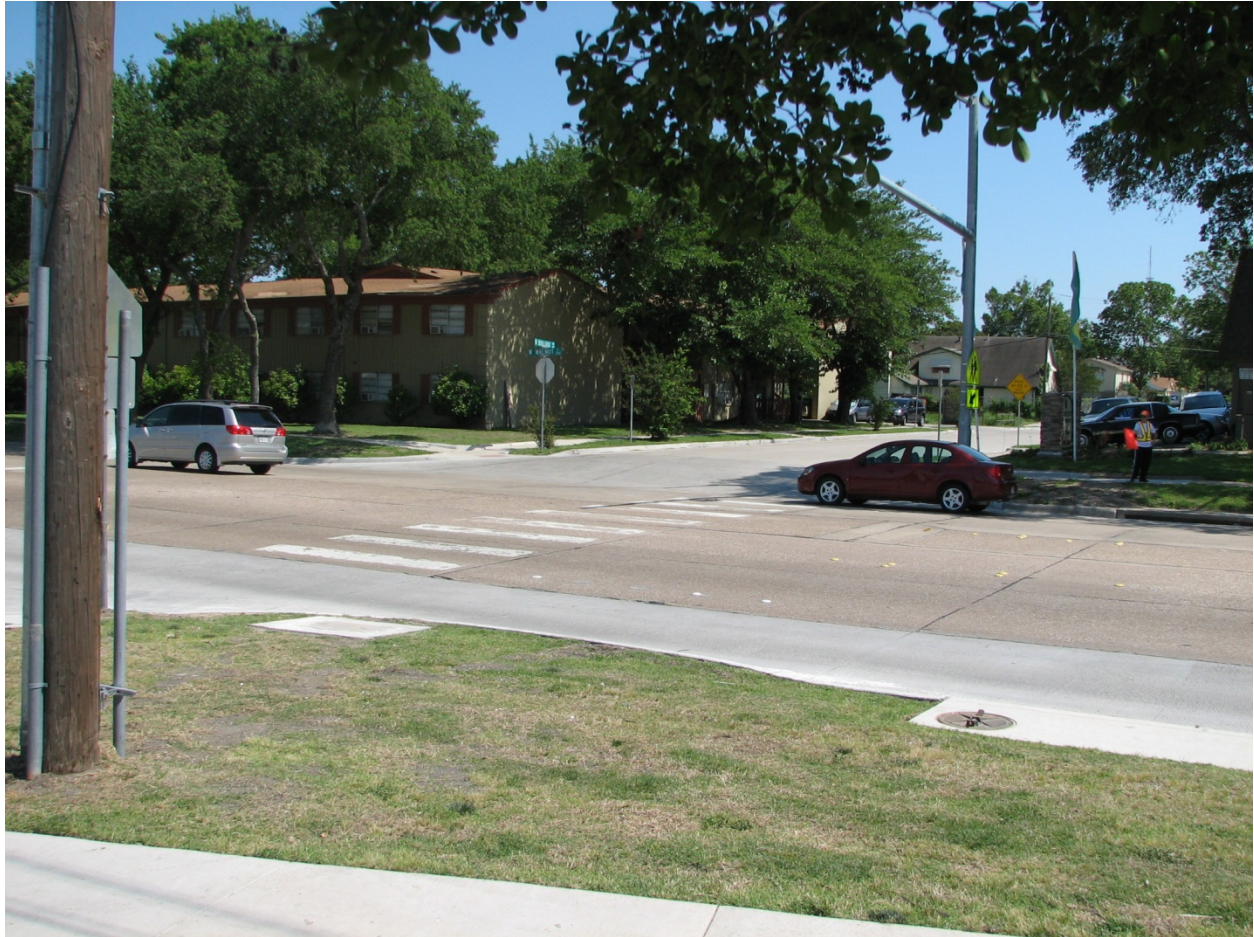
Figure 2. Crosswalk Prior to Installation of RRFB.

The subject crosswalk was recently improved as part of the development that opened the community center. Curb ramps were added at either end of the crosswalk where none previously existed, new fluorescent yellow-green School Crosswalk Warning Assembly signs (S1-1 and W16-7L) were posted on either end of the crosswalk, and a pole-and-mast arm assembly was installed on the south end of the crosswalk. The School Crosswalk Warning Assembly sign for eastbound traffic is mounted on the pole of this assembly.

An RRFB treatment was proposed to improve driver compliance with the crosswalk on Walnut Street. The treatment consists of a single RRFB assembly installed on the mast arm over the center of the TWLTL for each direction of travel, plus an additional pole-mounted RRFB assembly for each direction of travel on each side of the street. Data were collected at the crosswalk before installation of the RRFB and after installation. An image of the crosswalk prior to RRFB installation is shown in Figure 2.

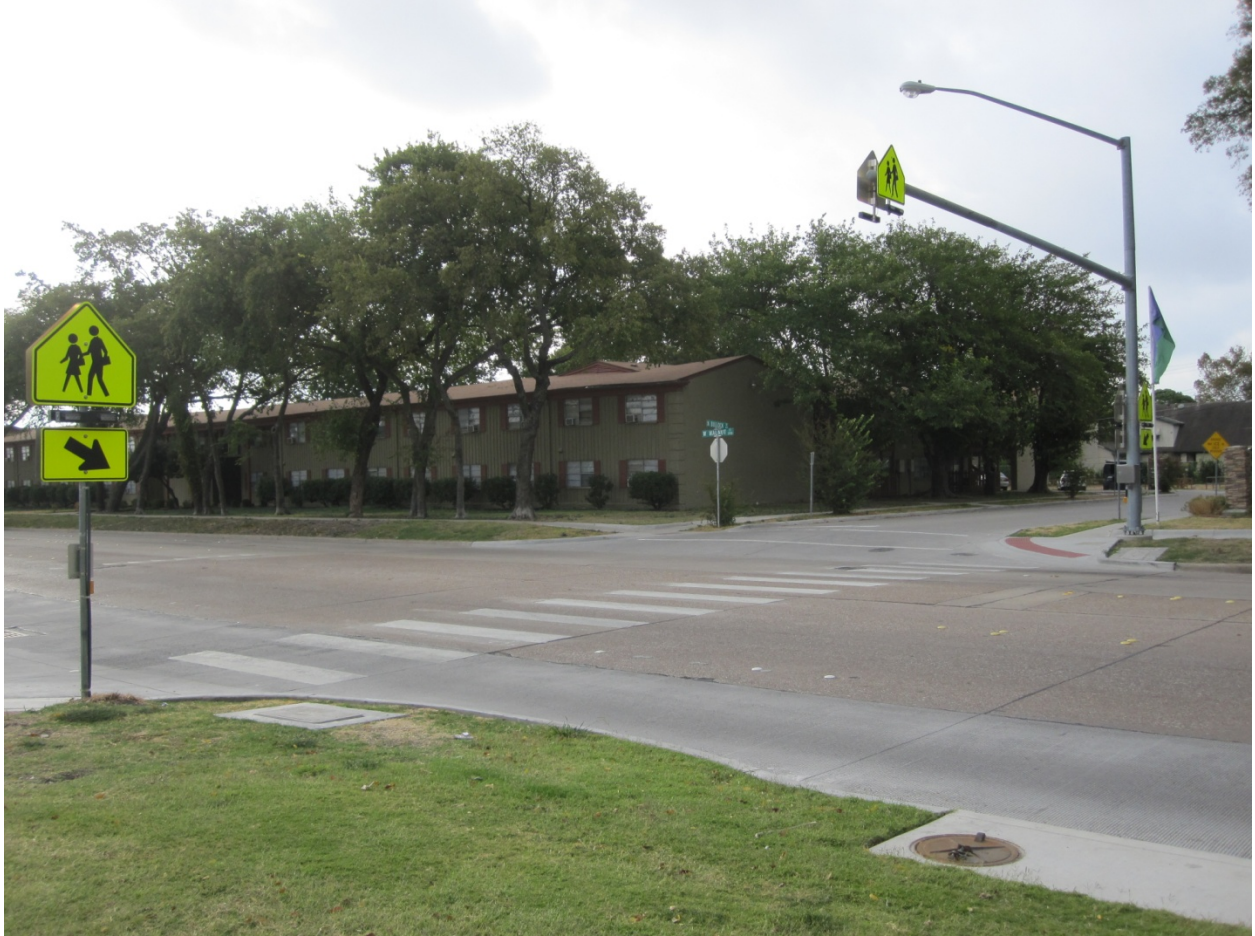
Figure 3. Crosswalk After Installation of RRFB.

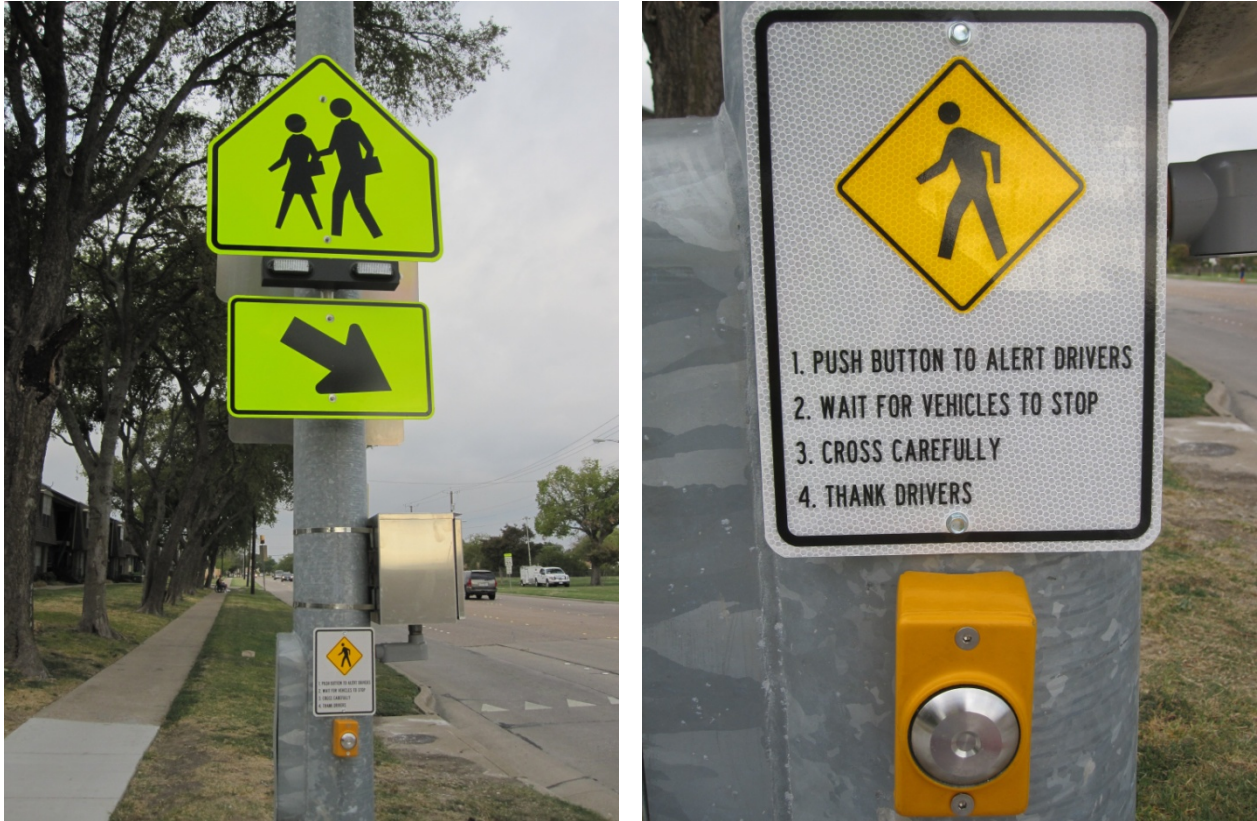
Figure 4. Pedestrian Pushbutton and Instructions for Use of RRFB.

To obtain consistent results that are appropriate for the expected behavior of the driver, crossing pedestrians needed to be “on the half of the roadway” in which vehicles were approaching. Many pedestrians do not do this, choosing to wait completely on the curb or curb ramp until all traffic has passed or yielded. In order to consistently gauge whether drivers would yield at an occupied crosswalk, pedestrians would have to place at least one foot off of the curb into the crosswalk to show intent to cross. Furthermore, the pedestrian would have to approach the crosswalk in such a way that an approaching driver would have sufficient time to respond to the pedestrian’s presence and slow down or stop before reaching the crosswalk. Research team members used such a method, approaching the crosswalk as drivers also approached, placing one foot into the crosswalk and then waiting for drivers to yield, or for all traffic to clear, before entering the crosswalk. For the data collection after installation, research team members also activated the RRFB system before placing a foot into the crosswalk.
